Technical Report CHL-99-6 May 1999

# Coastal Processes Assessment for Brevard County, Florida, with Special Reference to Test Plaintiffs

by Nicholas C. Kraus, WES

Final report

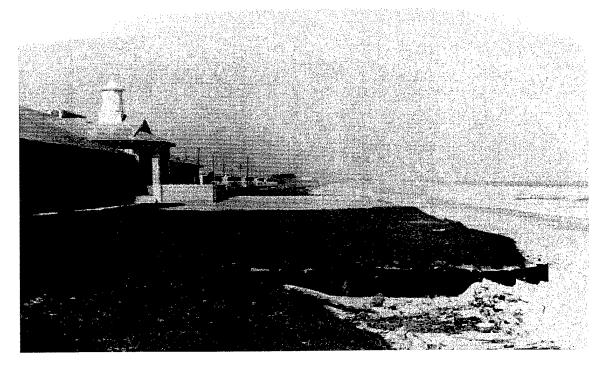
Figure 2-2. Officers Club at the Banana River Naval Air Station (Patrick AFB), February 13, 1948. Notice massive armoring on the property. The beaches of Brevard County were experiencing erosion by storms prior to the construction of Port Canaveral (source: USACE, Jacksonville District).

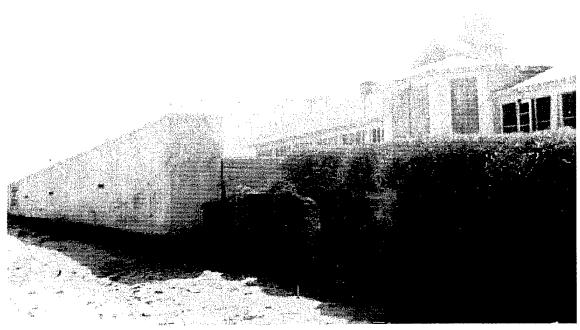
Figure 2-3. North end of concrete bulkhead at the Officers Club at the Banana River Naval Air Station (Patrick AFB), February 13, 1948 (source: USACE, Jacksonville District).

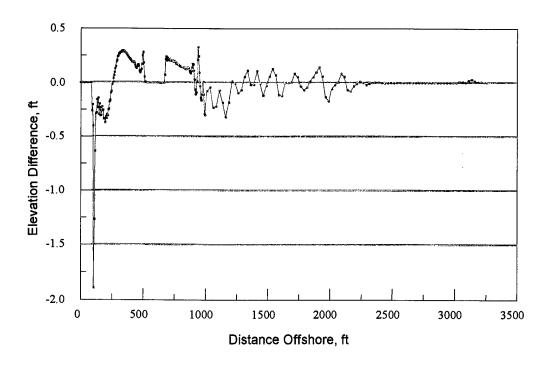
Figure 3-7. Difference in calculations between present work and Feasibility Study at R-124 for Tropical Storm Gordon (USACE 1996).

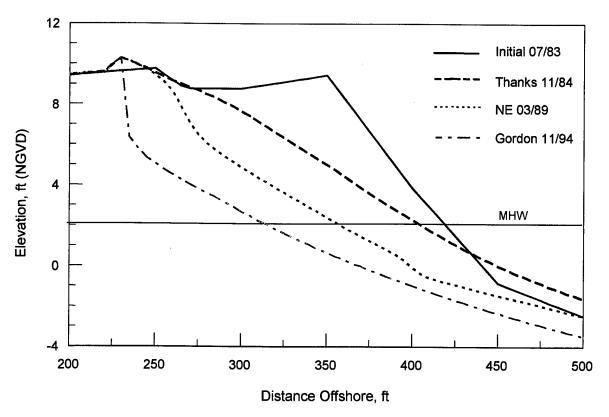
Figure 3-8. R-7: Beach recession by three selected recent storms.

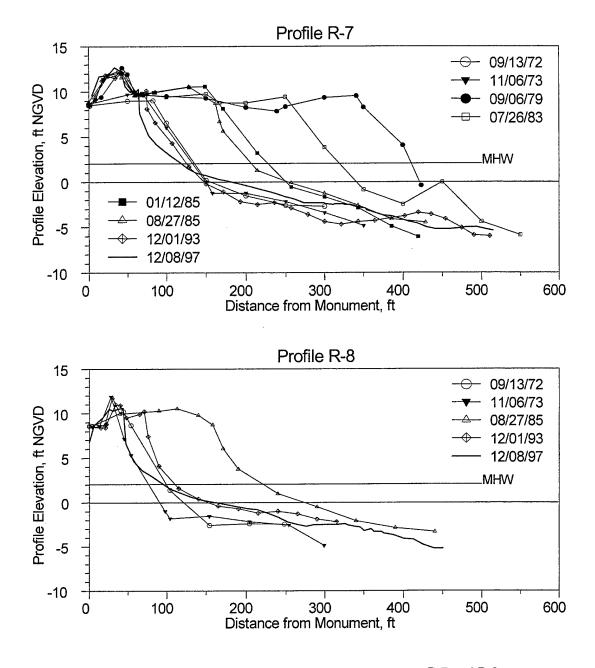
For comparison, beach-profile change between September 1972 and December 30, 1993, measured at R-7 and R-8 is plotted on Figure 3-9. Numerical calculations of beach-profile change for the three storms, with survey data from R-7 as the initial condition, give recession and erosion less than that documented by the surveys as described below. The magnitude of erosion at R-8, located approximately 900 ft to the south of R-7, is less significant because the nearest survey in time occurred on August 27, 1985. Comparison of the August 1985 surveys for both R-monuments indicates similar beach dimensions relative to the position of the dune.

Figure 3-9. Beach profile change at FDEP Monuments R-7 and R-8.

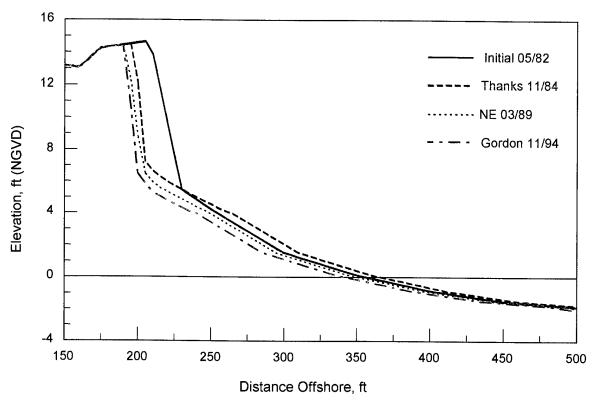
Calculation results at R-43 for the three selected storms, with the final profile position as post-TS Gordon, are shown in Figure 3-10. The storms caused moderate beach erosion and recession of the dune face, with the Thanksgiving Day northeaster of November 1984 producing the most erosion. In comparison with the beach recession calculated at R-7 for Applegate

(Figure 3-8), recession at R-43 is considerably less. The smaller recession at R-43 is attributed to the beach-face slope being closer to equilibrium than at R-7.

For R-43, SBEACH produced no washover because the dune crest was higher than the highest wave runup. Table 3-6 summarizes calculated change in MHW shoreline position and the loss of dune and beach volume landward of the location of the MHWL. Volume lost landward of the MHWL ranged between 2.1 and 3.9 cy/ft or 5.3 and 9.8 cu m/m of dune crest. These rates are in the lower range of storm-induced dune-erosion rates as documented by Savage and Birkemeier (1987).

Figure 3-10. R-43: Beach recession by three selected recent storms.

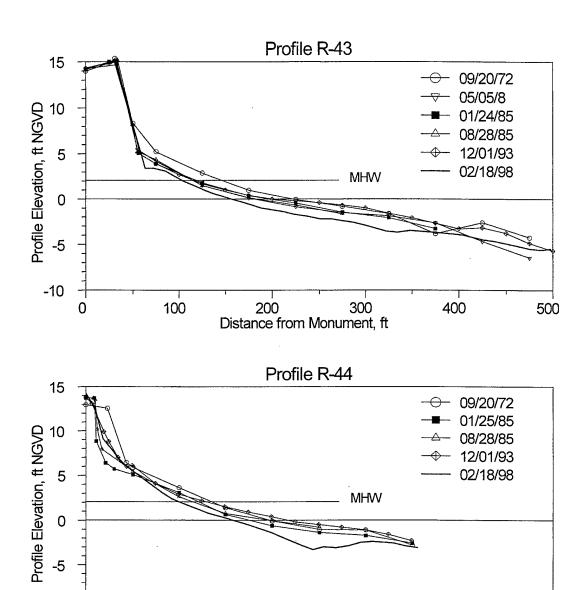
For comparison, beach-profile change between September 1972 and February 1998 measured at R-43 and R-44 is plotted on Figure 3-11. Profiles at Monument R-43 exhibit limited change from the dune crest to the MHW shoreline between May 1982 and December 1993. The lack of change at the dune face is attributed to shore-protection armoring. Profile R-44, 1,000 ft to the south, has not been armored, and the beach and dune responded differently to the storms.

From September 1972 to January 1985, at least 19 storms impacted the Brevard County coast (Appendix C). At R-44, the upper beach and dune face receded about 30 ft (Figure 3-11), mainly in response to the 1984 Thanksgiving Day storm. Significant beach and dune recession was described in the local newspapers for the Noro property and at other properties as a consequence of this storm. Calculations of beach and dune erosion caused by storms were performed for the profile at R-43 without representing the armoring. The modeling calculations produce almost the same erosion as that measured at R-44, which is not armored.

Similar to beach changes recorded at R-7, where simulated storm impacts accounted for a significant portion of measured erosion and recession, all of the erosion on the upper beach (above 5 ft NGVD) and the dune face at R-43 and R-44 can be attributed to storm-induced erosion. Storm-induced beach-volume loss at Noro for the time of purchase is calculated from Table 3-6 as  $(2.8+2.1 \text{ cy/ft}) \times 100 \text{ ft} = 490 \text{ cy}$ .

Figure 3-11. Beach profile change at FDEP Monuments R-43 and R-44.

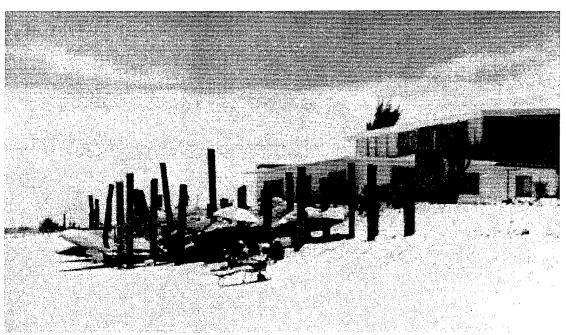
Don and Gale Applegate purchased their property in August 1981 for \$15,000. At the time of purchase, there was no dune in front of the structure, but much of the 1974/75 beach fill still remained. Figure 4-1 shows the location of the Applegate house relative to the dune line in August 1971, and Figure 1-2 shows almost the same view in May 1996. The house had been located approximately 200 ft seaward of all other houses south of the Harbor in Brevard County. In the 1960s, concrete rubble and automobile parts were placed in front of the property in an attempt to protect against storm waves and flooding (Figure 4-1 and Figure 4-2) and were still

Figure 4-1. Applegate property, August 1971. Presence of pilings and concrete rubble indicates this particular structure was vulnerable to wave action 10 years after construction (source: USACE, Jacksonville).

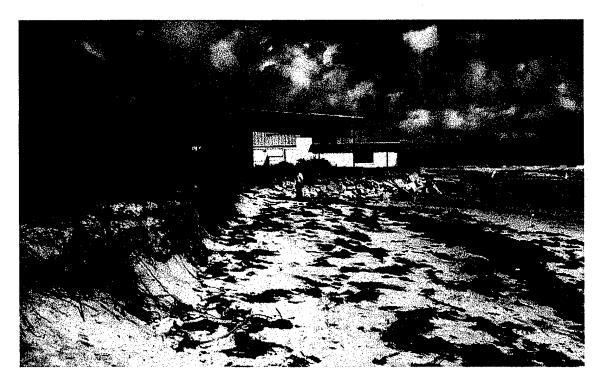
Figure 4-2. Applegate property viewed from the south adjacent property, February 20, 1997. Location of Applegate residence and rubble on the beach face and in front of the dune line is clearly evident (source: N. C. Kraus).

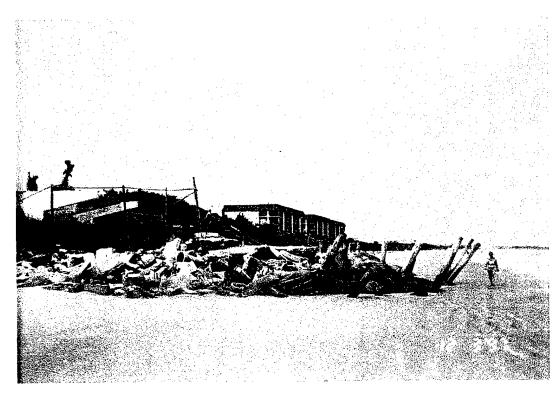
Figure 4-4. Side view of Applegate property, December 3, 1997 (source: N. C. Kraus).

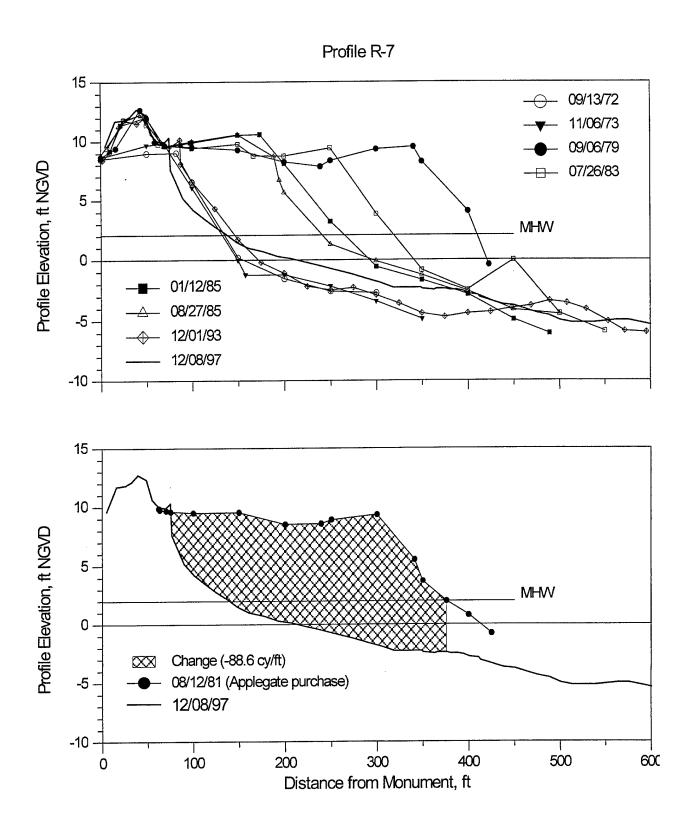
The value of 8,500 cy is an overestimate of loss because the natural beach and dune adjacent to the Applegate property (used to estimate loss at Applegate) eroded more than the armored Applegate property.

Figure 4-5. Beach profile surveys at Monument R-7 and calculated volume loss from the time of purchase (August 12, 1981).

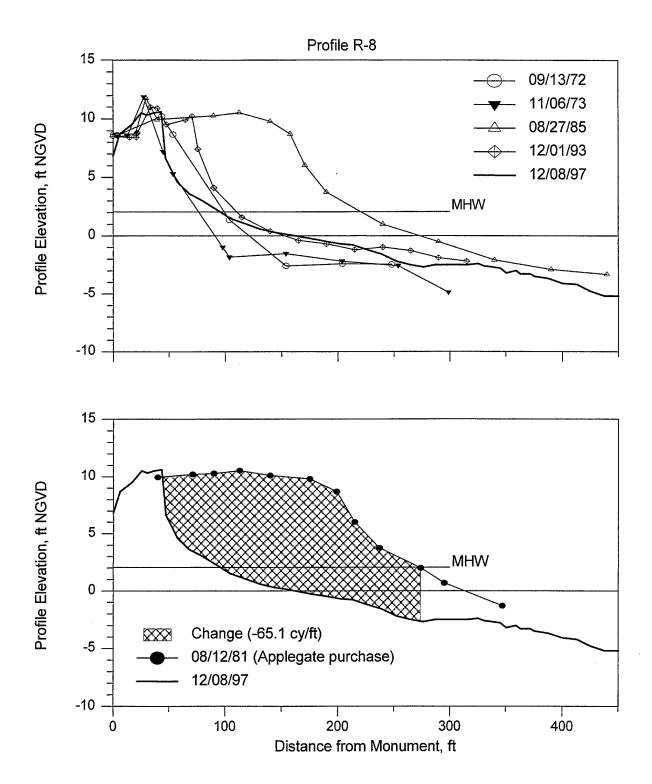
Figure 4-6. Beach profile surveys at Monument R-8 and calculated volume loss from the time of purchase (August 12, 1981).

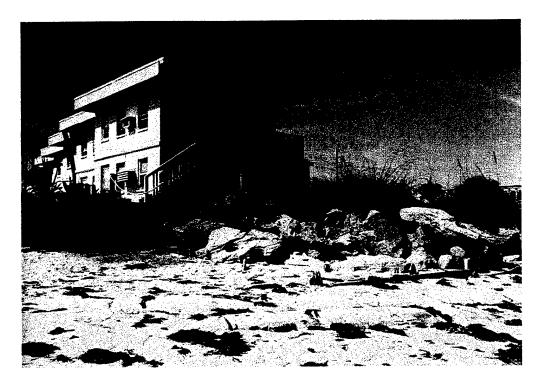
The 1984 Thanksgiving Day northeaster struck the coast of Brevard County 2 years before Noro purchased the property. This storm removed the beach, destroyed the wooden bulkhead built to protect the property against storm waves, and eroded the dunes at the site. A local newspaper (*Florida Today* 11/24/84) reported that the foundation of "Pelican Landing Resort in Cocoa Beach hangs over dunes edge..." after the Thanksgiving Day storm. The remains of the wooden bulkhead can be seen in Figures 4-7 and 4-8. This bulkhead indicates response to and anticipation of dune erosion caused by storms, because long-term change of the MHW shoreline has been negligible for at least 30 years. During low tide, a substantial beach is observed in front of the Noro property, as seen in Figure 4-9.

Figure 4-7. View of rock revetment and remnant wooden bulkhead seaward of the Pelican Landing Resort, February 20, 1997 (source: N. C. Kraus).

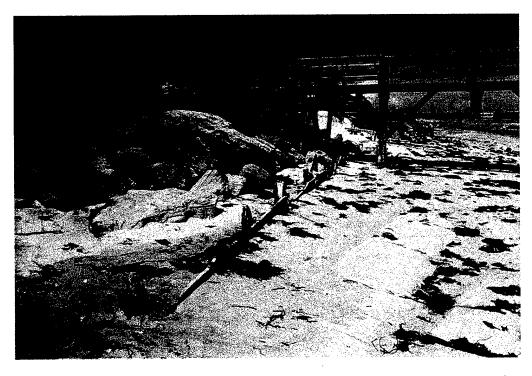
The northern border of the property is located 395 ft south of Monument R-43, and the property is 100 ft wide. The adjacent beach properties in this area are mostly armored. Presently, the Noro property is protected by sandbags (geotextile armoring units) placed around its seaward perimeter, and remnants of a rock revetment (or rubble) and a wooden bulkhead can be observed (see Figures 4-7 and 4-8). The bulkhead protected the property prior to the time of purchase, but it was destroyed in the Thanksgiving Day northeaster of 1984.

Figure 4-8. Oblique view of remnant wooden bulkhead, rock revetment, and sandbags along the seaward side of the Noro Property (Pelican Landing), February 20, 1997 (source: N. C. Kraus).

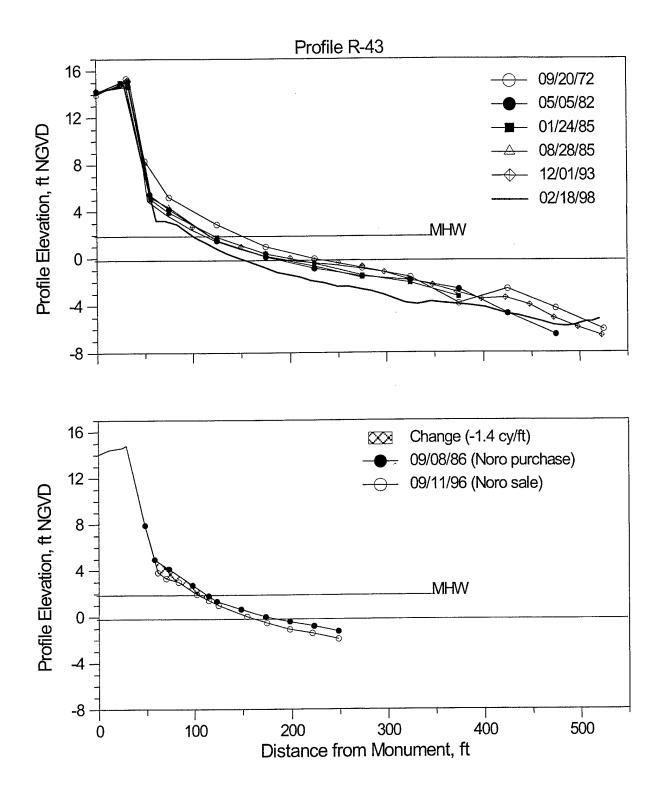
Configurations of beach profiles at R-43 and R-44 were established for the period of ownership by interpolation between profiles bracketing September 8, 1986, and September 11, 1996. Changes in sand volume are 1.4 and 0.0 cy/ft net erosion at R-43 and R-44, respectively (See Figure 4-10 and Figure 4-11). These values produce an average loss in sand-volume per

Figure 4-10. Beach-profile surveys at Monument R-43 and calculated volume loss from the time of purchase (August 12, 1981).

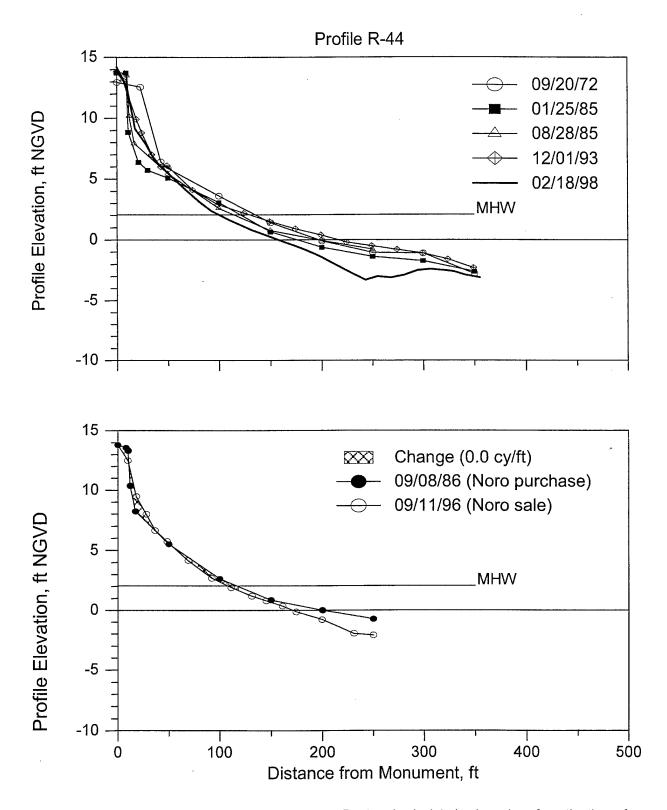
In agreement with the loss in sand volume determined from measurements at the Noro property during the time of ownership, numerical calculations of potential<sup>34</sup> storm-induced beach and dune change indicate that the volume loss on the upper beach and dune south of the property (Monument R-44) was caused by storms. The existing armoring at the property should prevent dune erosion by wave action during ordinary high tides, so that only elevated water levels that accompany major storms will erode the dune face. Therefore, storms are deduced to be the dominant factor producing dune recession at the Noro property and not blockage of longshore sand transport by Canaveral Harbor.

Figure 4-11. Beach-profile surveys at Monument R-44 and calculated volume loss from the time of purchase (August 12, 1981).

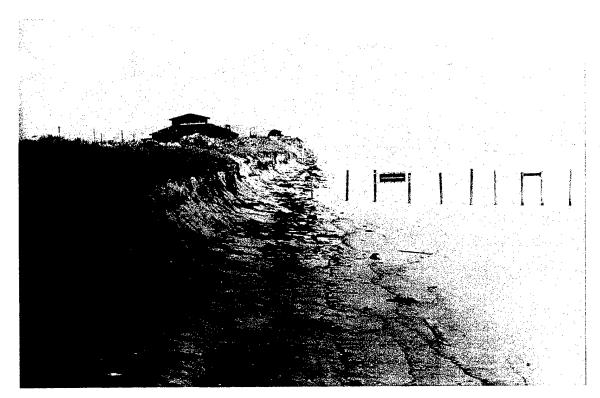
Figure D-2: Canaveral National Seashore at the Brevard/Volusia County line on September 6, 1979, showing storm damage to the dunes from Hurricane David (source: USACE, Jacksonville District).

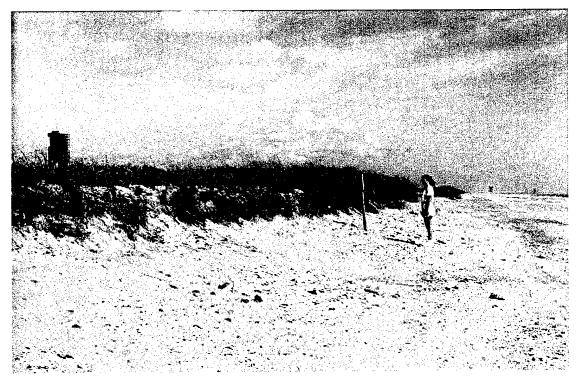
Figure D-3: NASA Federal Property at the tip of Cape Canaveral on May 10, 1996. Damage to the dunes from past storms is still visible (source: N. C. Kraus).

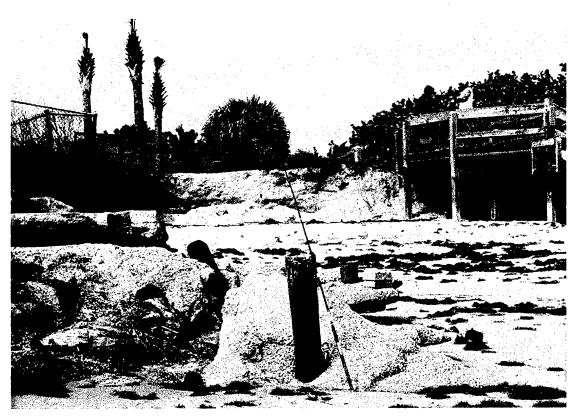
Figure D-18: Dune face directly north of Applegate property, February 20, 1997, indicating storm erosion (source: N. C. Kraus).

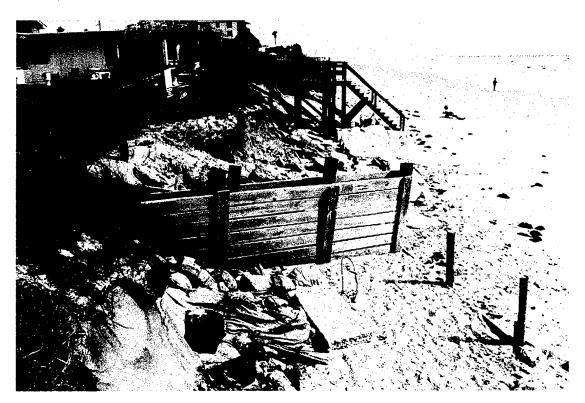
Figure D-22: View north from Noro and Co. property, May 9, 1996, showing storm damage to the dunes and the remains of attempts to protect upland properties (source: N. C. Kraus).

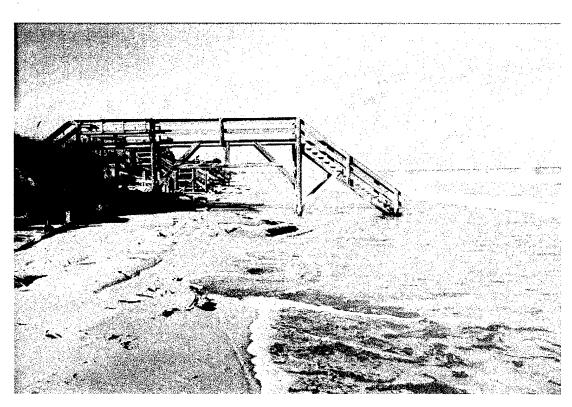
Figure D-24: View north of the boardwalk at Noro and Co. property, November 21, 1996, showing the narrow beach associated with a typical winter profile (source: N. C. Kraus).

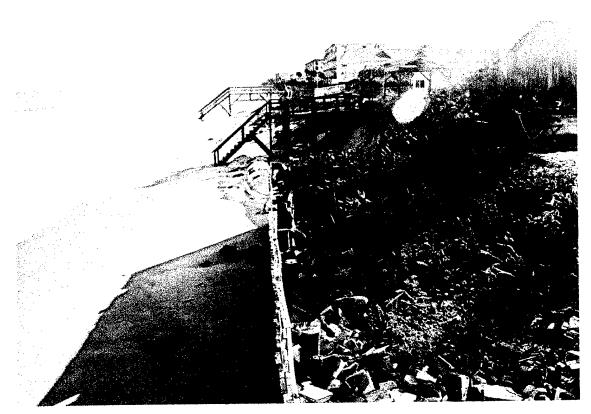
Figure D-26: View south towards Noro property showing the eroded dunes on one property and the creative armoring structures on the neighboring property to the north (source: N. C. Kraus).

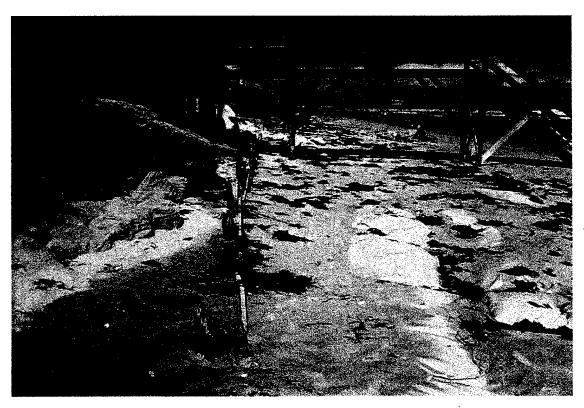
Figure D-29: View north of Noro and Co. property showing the remains of the wooden bulkhead and rock revetment, February 20, 1997( source: N. C. Kraus).
